DESTRUCTIVE EXAMINATION METHODS FOR THE INVESTIGATION OF NORTH ANNA HEAD PENETRATION #54

Presentation to
NRC Research
Rockville, MD
January 18, 2006

Gutti Rao
Westinghouse Electric Company

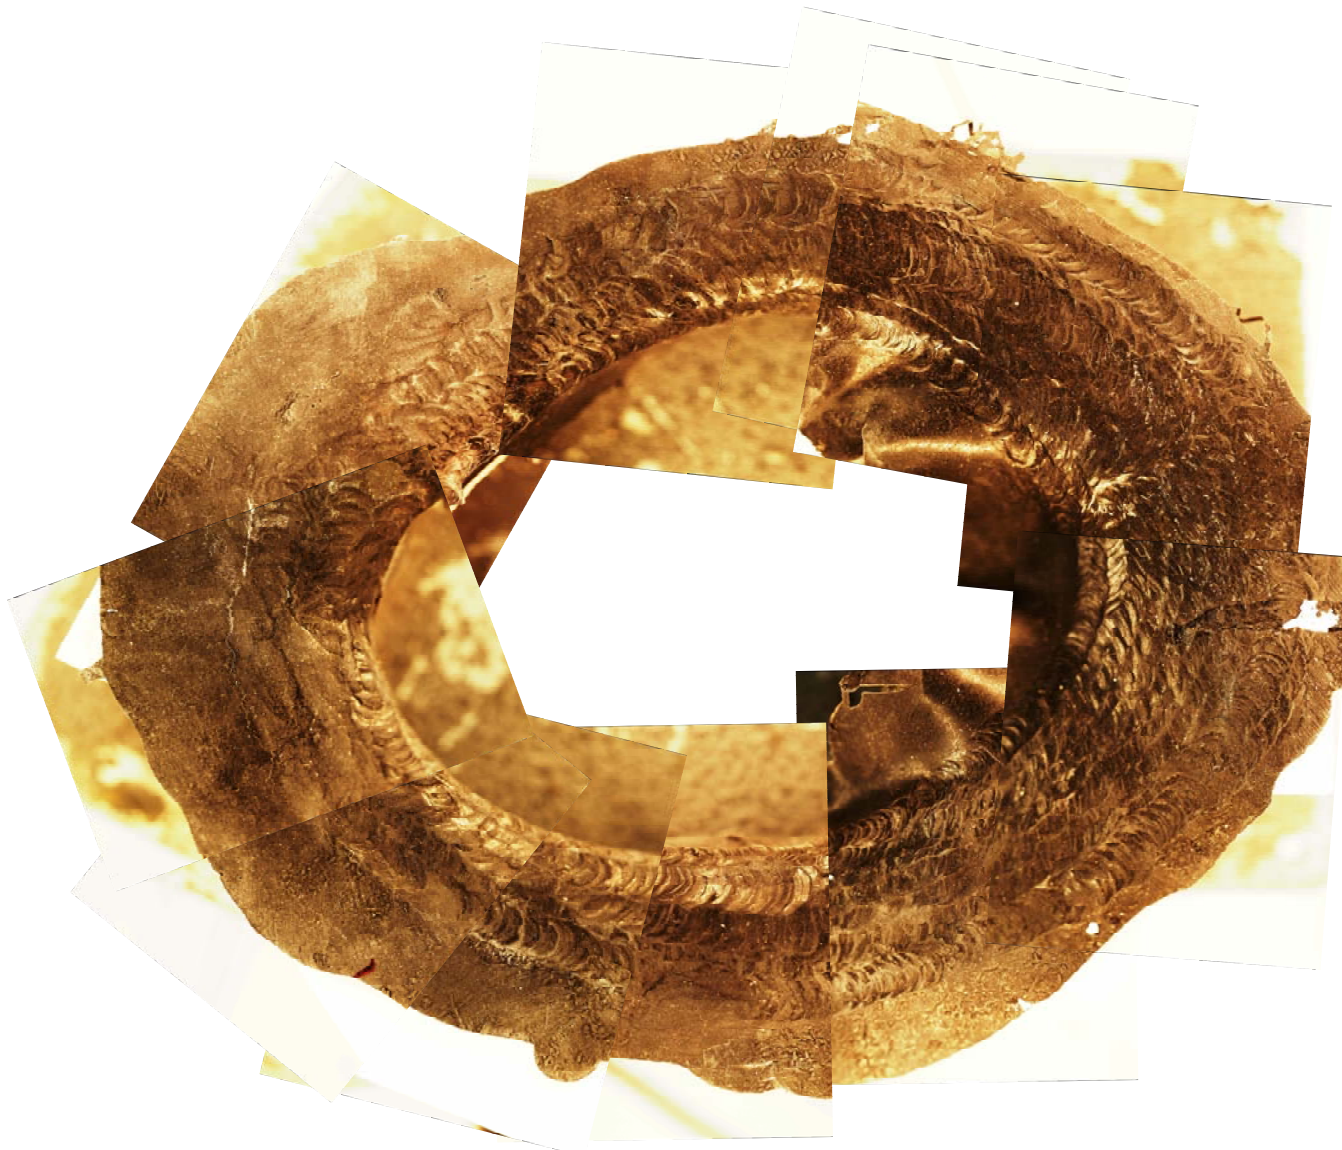
NDE Assessments – For Sub-Surface/Surface Emergent Crack Identification

- Microset (High Resolution) Replication
- Eddy Current Testing
- Florescent Dye Penetrant Testing
- Ultrasonic Testing

Replication to Preserve Data from Wetted ID Face Weld

Allows Identification of Crack Emergence on J-Weld Wetted ID Face and Observation of Weld Bead Interactions

Replication Allowed Identification of Several Wetted Face Emergent Cracks – this one at 300° Location 7015.ppt

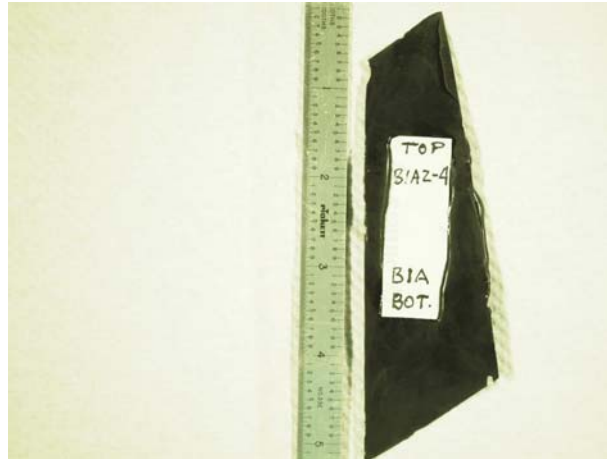
ID Replica Across
J-weld Region

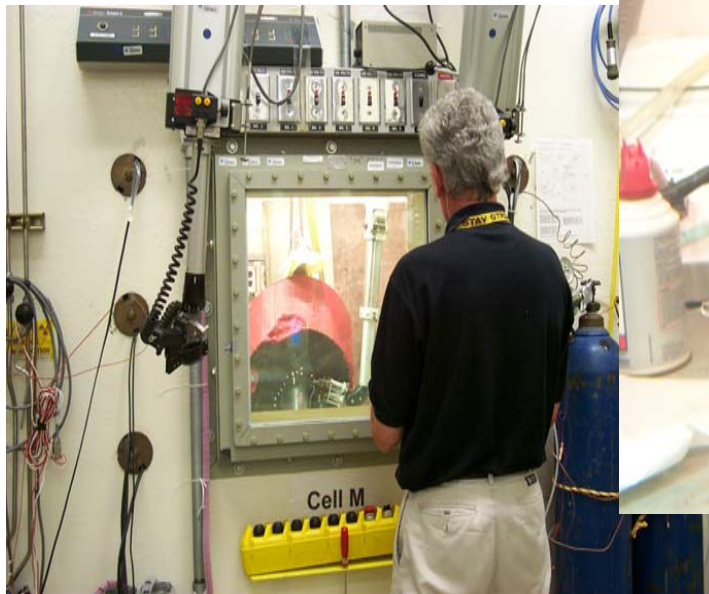
EC Pencil Probe Tracing of Weld Interface

To Confirm Profile of Weld Interface (Establishes Removable Excess Carbon Steel)

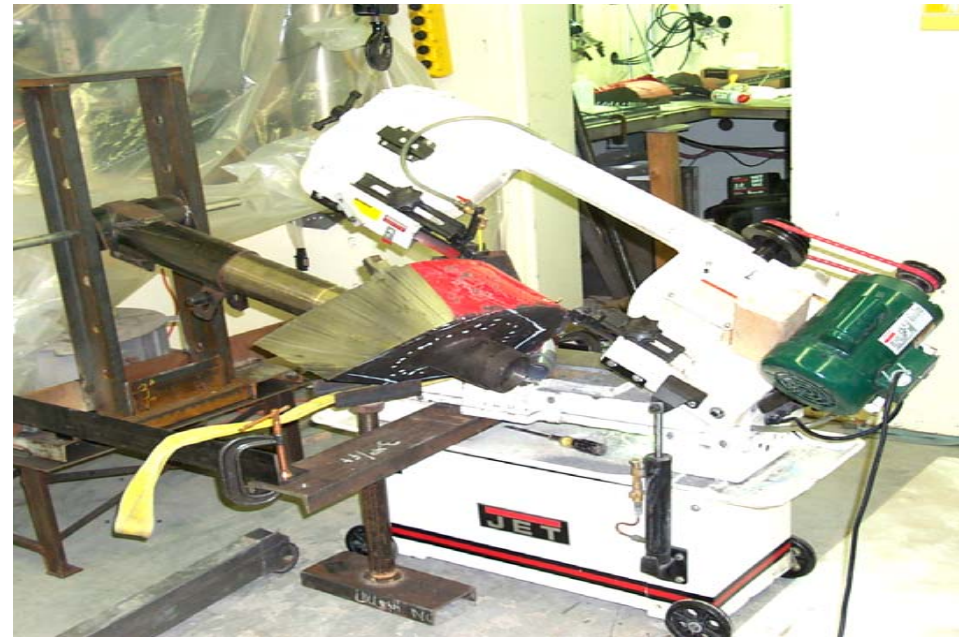
- Fixture Capable of Rotational, Elevation and Lateral Adjustment
- Sample Holding Fixture Clamped to Saw Base to Assure Rigidity Between Sample and Saw Blade
- Top of CRDM Penetration Clamped to Fixture and Aligned with Blade
- Ratchet Cargo Straps were used to Maintain Position and Rigidity During Cut

Piece in Fixture for Removal of Excess Carbon Steel

- Band Saw was Used with Appropriate Capacity (Modified Jet, 7x12" Horizontal/Vertical Band Saw). Recommend Use of Larger Saw.
- A 3/4 in Bimetal 5/8 in Variable Pitch Blade (Blade was Changed Frequently, Especially when Cutting Through Weldment). Speed, Feed and Pitch of Blade were Dependant on Horsepower of Drive Motor and Rigidity of Fixturing.
